***2017 ASPECT Preliminary Report  
Rapids Needs Assessment &  
Arkema Plant Response, Crosby, TX***

***September 3, 2017  
0730 hrs to 2040 hrs***

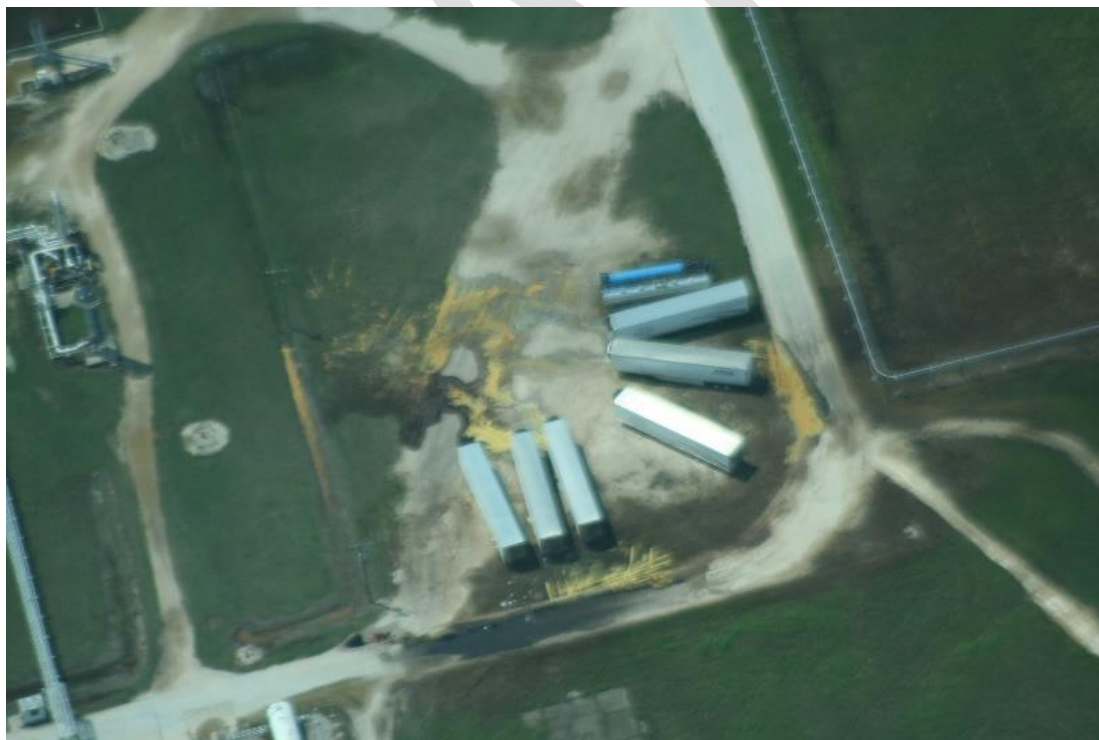
*Figure 1: Remaining trailers at the Arkema site.*

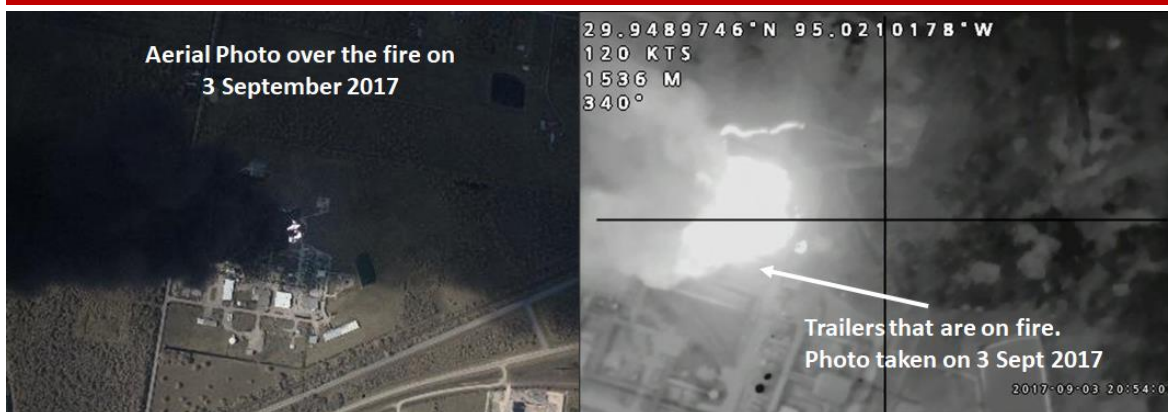
1540 hrs: ASPECT reports fire at the Arkema site and initiated a series of chemical sweeps. Figure 3 shows an aerial photo and infrared image that was pulled from the aircraft and shared with the Region EOC.

*Figure 3: Aerial photo (left) taken at 5,000 ft of the Arkema trailers. Infrared image taken from the IR video showing the heat signature of the fire.*

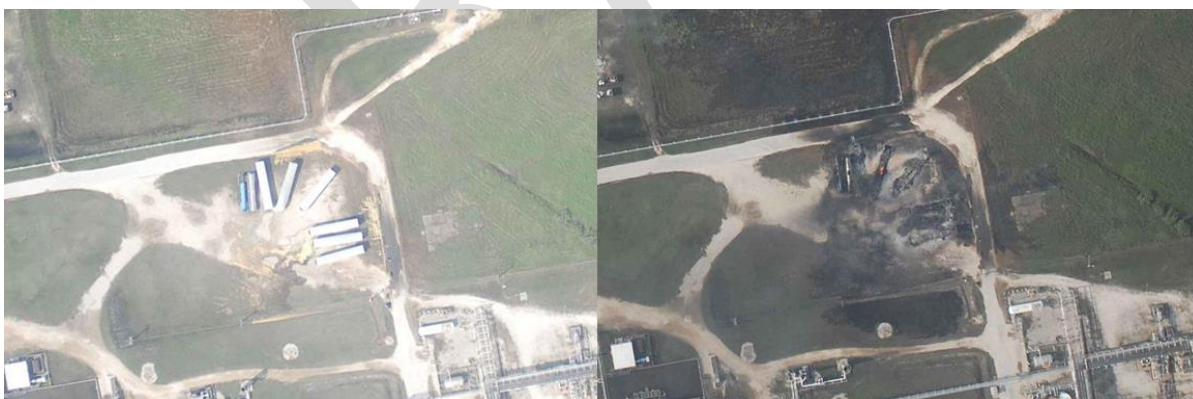
Figures 4, 5 and 6 show aerial and oblique photos of the Arkema trailers before, during, and after they burned.

*Figure 4: Before (left) and after (right) the Arkema site trailers burned*

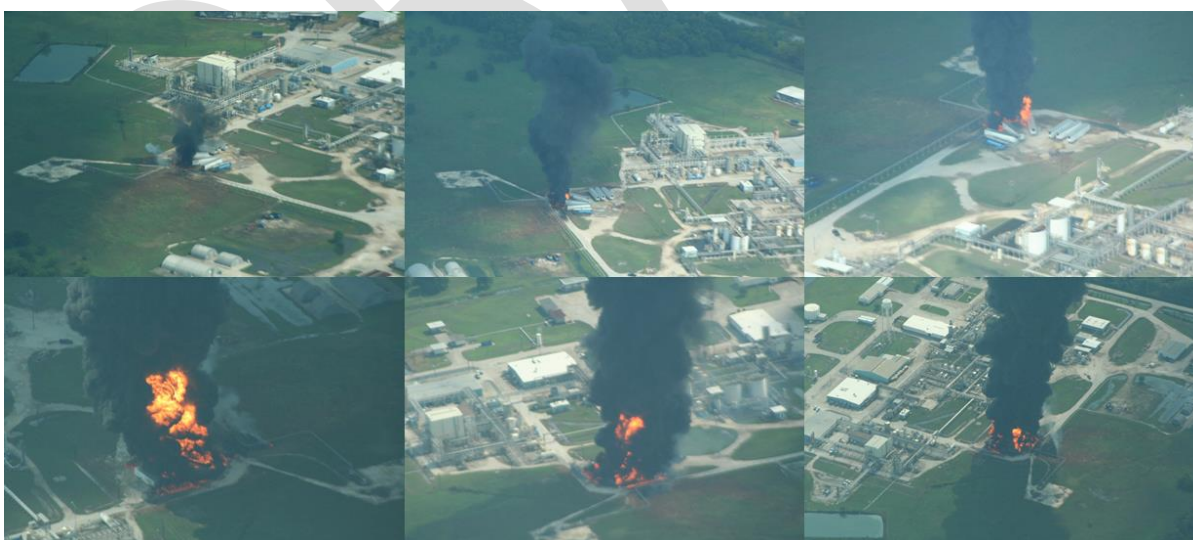
*Figure 6: Series of oblique photos showing the progress of the Arkema trailers burning.*

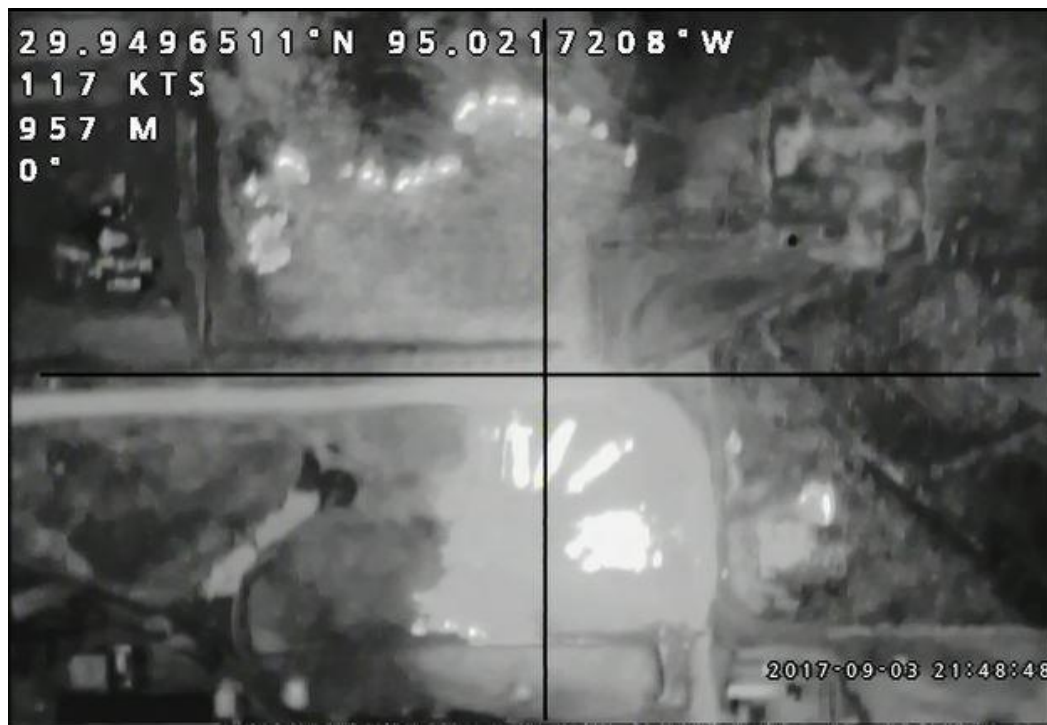
*Figure 7: Infrared image taken from the IR video (1650 hrs CST) showing the trailers producing a heat signature near the end of the burn.*
